Use Attainability Analysis

WBID 1247 Little Pomme De Terre

Submitted by
SES, Inc.

To
Missouri Department of Natural Resources
Water Protection Program

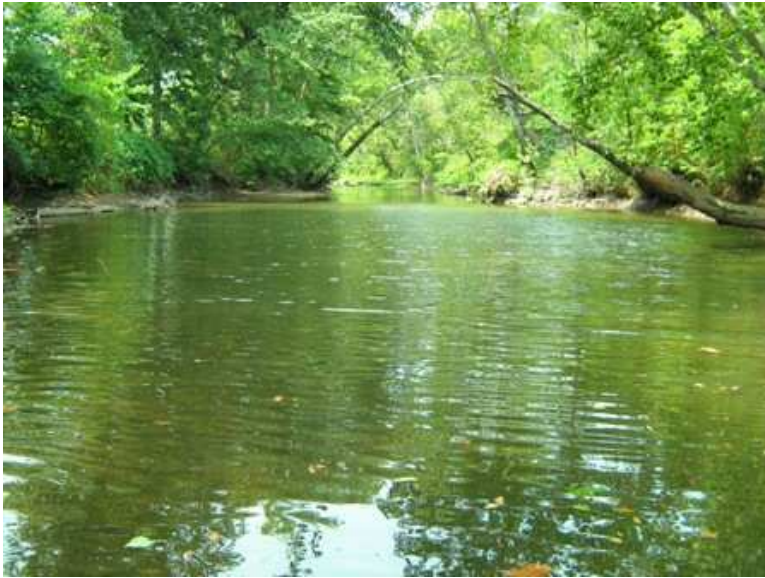
Site# 1 Photo ID# 32, Upstream

WBID #	1247	Site #	1				
Mark #	45	Dissolved Oxygen (ppm)	7.2				
Upstream Views Physical Dimensions:		Is there any water present at this view?		y			
		If so, is there an obvious current?		n			
Select one of the following channel features:							
	% of Channel Feature						
Riffle	0						
Run	0						
Pool	100						
Downstream View's Physical Dimension		Is there any water present at this view?		n			
		If so, is there an obvious current?					
Substrate:							
41% Cobble		55% Gravel		4% Sand		% Silt	
% Mud/Clay		% Bedrock					
Aquatic Vegetation: (Note amount of vegetation or algal growth at the assessment site)							
<div>15% water lily and coontail.</div>							
Water Characteristics							
Odor	Sewage	Musky	Chemical	<u>None</u>	Other		
Color	Clear	<u>Green</u>	Gray	Milky	<u>Other</u>	<u>Brown</u>	
Bottom Deposit	Sludge	Solids	Fine Sed.	<u>None</u>	Other		
Surface Deposit	Oil	Scum	Foam	<u>None</u>	Other

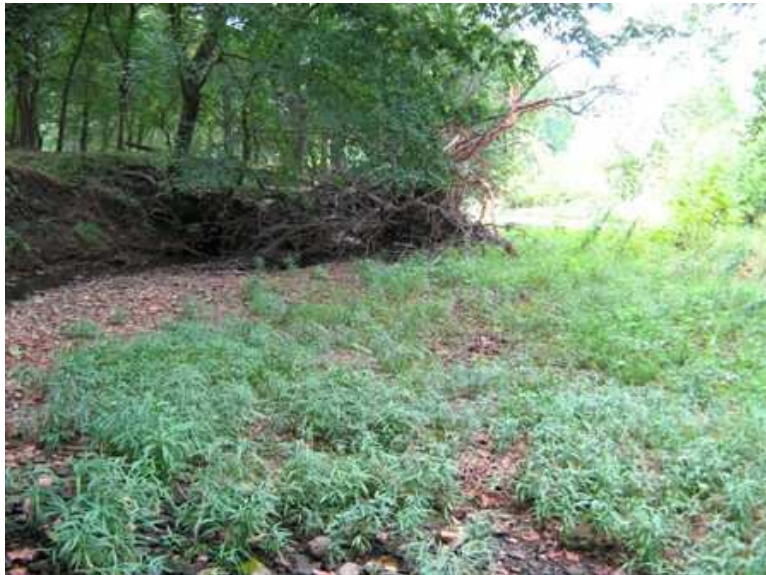
Site# 2 Photo ID# 33, Upstream

WBID #	1247	Site #	2			
Mark #	46	Dissolved Oxygen (ppm)	8.7			
Upstream Views Physical Dimensions:		Is there any water present at this view?			y	
		If so, is there an obvious current?			n	
Select one of the following channel features:						
	% of Channel Feature					
Riffle						
Run	91					
Pool	9					
Downstream View's Physical Dimension		Is there any water present at this view?			y	
		If so, is there an obvious current?			n	
Substrate:						
82% Cobble		9% Gravel		% Sand	% Silt	
% Mud/Clay		9% Bedrock				
Aquatic Vegetation: (Note amount of vegetation or algal growth at the assessment site)						
50% small willow and 5% coontail						
Water Characteristics						
Odor		Sewage	Musky	Chemical	<u>None</u>	Other
Color		<u>Clear</u>	<u>Green</u>	Gray	Milky	Other
Bottom Deposit		Sludge	Solids	Fine Sed.	<u>None</u>	Other
Surface Deposit		<u>Oil</u>	Scum	Foam	None	Other

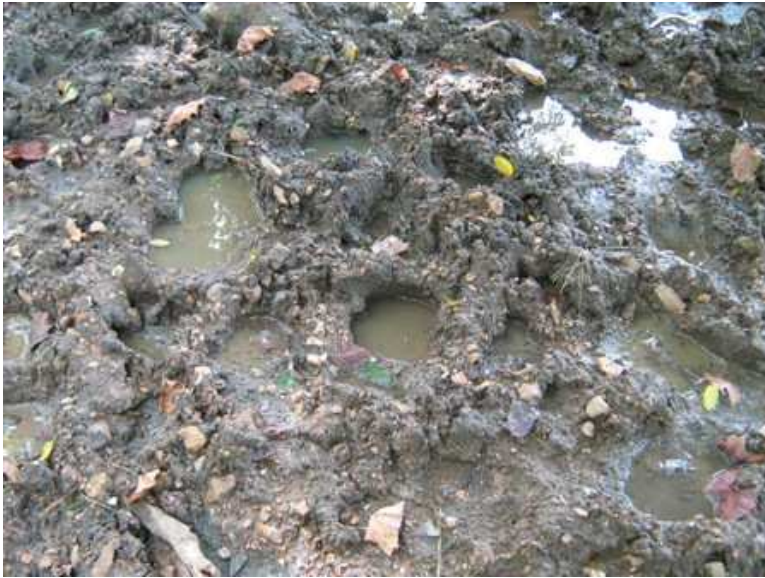
Site# 2 Photo ID# 35, Livestock watering

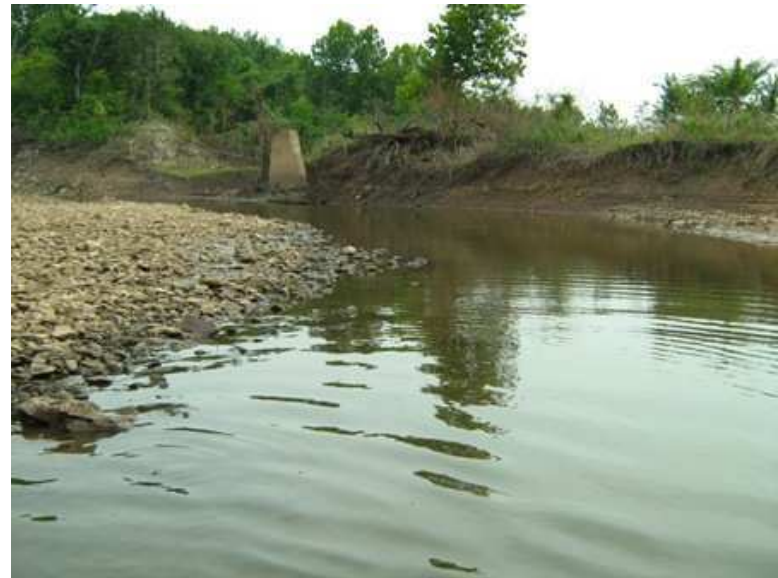
Site# 3 Photo ID# 36, Upstream

WBID #	1247	Site #	3				
Mark #	47	Dissolved Oxygen (ppm)	10.2				
Upstream Views Physical Dimensions:		Is there any water present at this view?		y			
		If so, is there an obvious current?		n			
Select one of the following channel features:							
	% of Channel Feature						
Riffle							
Run	100						
Pool							
Downstream View's Physical Dimension		Is there any water present at this view?		y			
		If so, is there an obvious current?		n			
Substrate:							
% Cobble		50% Gravel		% Sand		50% Silt	
% Mud/Clay		% Bedrock					
Aquatic Vegetation: (Note amount of vegetation or algal growth at the assessment site)							
none							
Water Characteristics							
Odor		Sewage	Musky	Chemical	<u>None</u>	Other	
Color		Clear	Green	Gray	Milky	<u>Other</u>	<u>Brown and cloudy</u>
Bottom Deposit		Sludge	Solids	<u>Fine Sed.</u>	None	Other	
Surface Deposit		Oil	Scum	Foam	<u>None</u>	Other

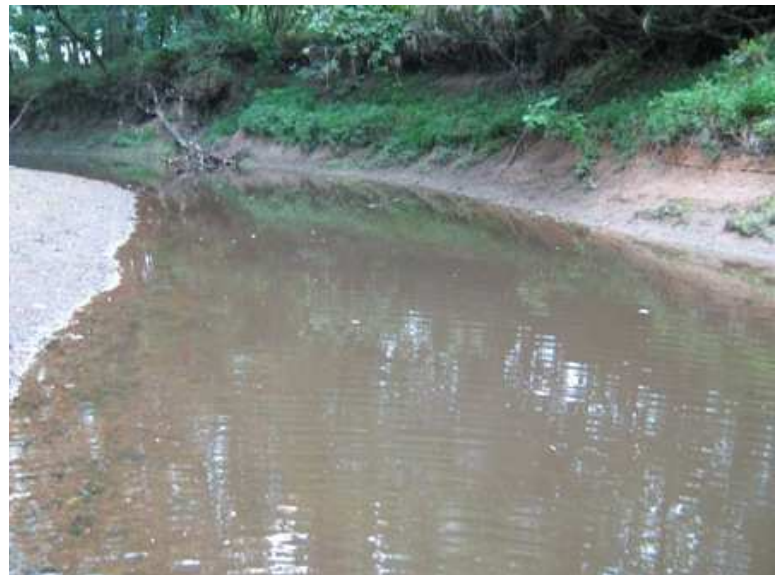
Site# 4 Photo ID# 38, Upstream

WBID #	1247	Site #	4				
Mark #	48	Dissolved Oxygen (ppm)	11				
Upstream Views Physical Dimensions:		Is there any water present at this view?				y	
		If so, is there an obvious current?				n	
Select one of the following channel features:							
	% of Channel Feature						
Riffle	0						
Run	64						
Pool	36						
Downstream View's Physical Dimension		Is there any water present at this view?				y	
		If so, is there an obvious current?				n	
Substrate:							
9% Cobble		91% Gravel		% Sand		% Silt	
% Mud/Clay		% Bedrock					
Aquatic Vegetation: (Note amount of vegetation or algal growth at the assessment site)							
5% trees in stream.							
Water Characteristics							
Odor		Sewage	Musky	Chemical	<u>None</u>	Other	
Color		Clear	<u>Green</u>	Gray	Milky	Other	
Bottom Deposit		Sludge	Solids	<u>Fine Sed.</u>	None	Other	
Surface Deposit		Oil	Scum	Foam	<u>None</u>	Other
